On the intermetallic constituents in the sodium-induced edge cracking of hot-rolled AA5182 aluminum alloys

Mohammadreza Mofarreh, Mousa Javidani, X.-Grant Chen *

Department of Applied Science, University of Quebec at Chicoutimi, Saguenay, QC,
G7H 2B1 Canada

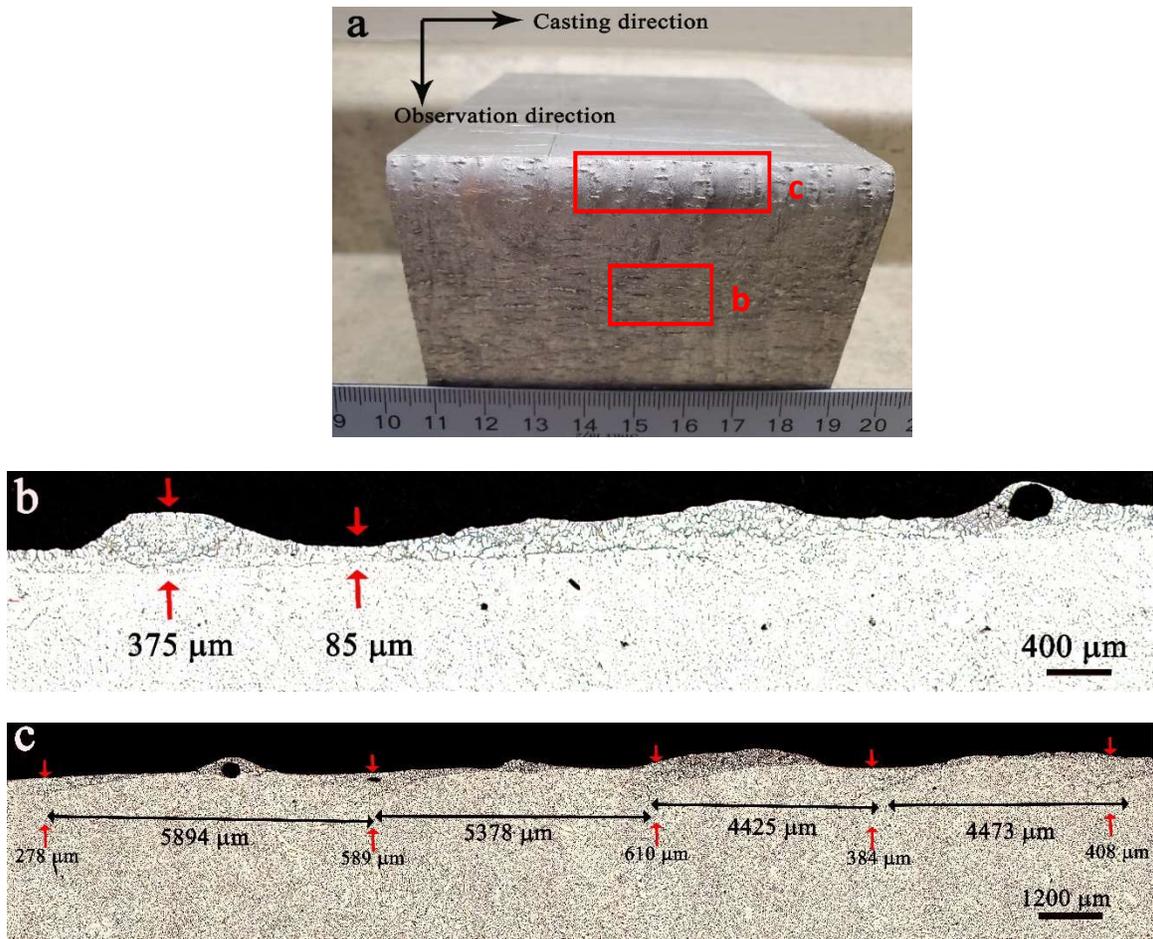
The edge cracks during rolling were all initiated from the subsurface region of the DC-cast ingot, and then propagated toward the ingot bulk in different extensions. Therefore, the microstructure analyses were focused on two distinct regions: the subsurface region that covers the ingot cast surface to several millimeters inwards, and the bulk region. Representative micrographs from the subsurface region are shown in Fig. 3. The cast surface from the short side of the DC-cast ingot is shown in Fig 3a. From the cast surface, the first visible zone was the inverse segregation zone, which contains enriched intermetallic particles and solute elements, as shown in Fig 3b. The inverse segregation zone had a thickness that ranged from 85 to 250 μm and could occasionally extend to approximately 400 μm . In the subsurface region, there were meniscus bands (Fig. 3a and c), which were more noticeable at the corners of the ingot and presented a repetitive pattern along the casting direction with an interval of approximately $5.5 \pm 1.5 \times 10^3 \mu\text{m}$. These meniscus bands brought the inverse segregation zone (enriched intermetallic particles) toward the bulk with a depth of up to approximately 800-1000 μm .

Fig. 3. The cast surface and the microstructure in the subsurface region: a) cast surface of the short side of the ingot, b) the inverse segregation zone and c) the meniscus bands.

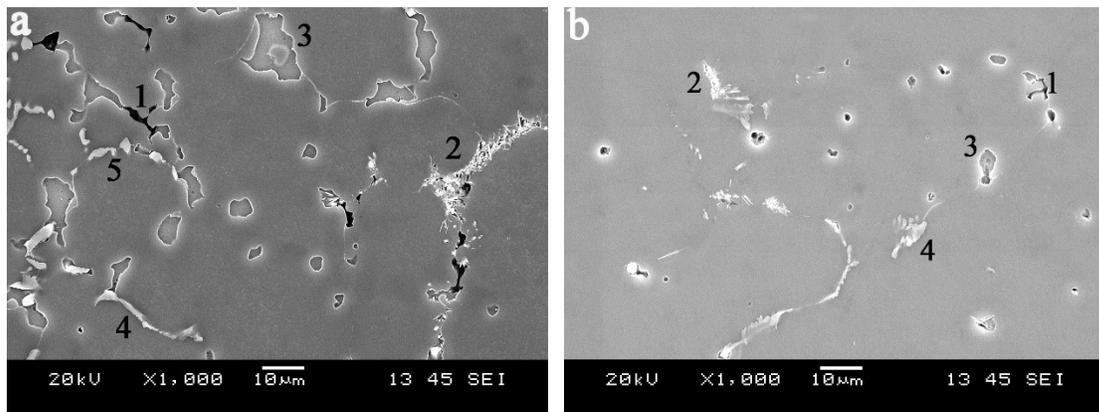
The typical as-cast microstructures of the subsurface and bulk region, displayed in Fig. 4, were composed of Mg_2Si , $\beta-Al_8Mg_5$, and Fe-rich intermetallics. Mg_2Si intermetallic particles with Chinese script morphology (Fig. 4, #1) and Fe-rich intermetallics were mostly located in the interdendrite regions. The Mg-rich $\beta-Al_8Mg_5$ particles (Fig. 4, #3) with a bulky morphology were the last eutectic intermetallic solidified in the interdendrite regions, where adequate Mg atoms were available [21,22]. The Fe-rich intermetallics appeared in three distinct types: $Al_6(Mn,Fe)$, $Al_3(Mn,Fe)$, and metastable $Al_m(Mn,Fe)$; these intermetallics were characterized by SEM-EDX analysis, and were consistent with the results reported in the literature [23–26]. $Al_6(Mn,Fe)$ particles had a plate-like morphology (Fig. 4, #4), while $Al_3(Mn,Fe)$ particles were distinguished by a needle-like morphology (Fig. 4, #2). The metastable $Al_m(Mn,Fe)$ particles also presented a plate-like shape and appeared only in the subsurface region (Fig.4, #5). The type and morphology of the intermetallic constituents were similar between the inverse segregation zone (Fig. 4a) and the bulk material (Fig. 4b). However, the quantity of intermetallic constituents in the inverse segregation zone was much higher than that in the bulk. The results of the quantitative image analysis indicated that the volume fraction of Mg_2Si was five times higher in the inverse segregation zone relative to the bulk, while the volume fractions of Fe-rich intermetallics and $\beta-Al_8Mg_5$ particles were two and eight times higher, respectively (Table 3). It is worth mentioning that the trace amount of Na did not affect the type and morphology of the intermetallic phases, and therefore, the results in Figs. 3 and 4 and Table 3 are valid for both high Na and low Na (HS and LS) alloys.

Fig. 4. SEM images of the as-cast microstructure at a) the inverse segregation zone and b) bulk: (1) Mg_2Si , (2) $Al_3(Mn,Fe)$, (3) $\beta-Al_8Mg_5$, (4) $Al_6(Mn,Fe)$, (5) $Al_m(Mn,Fe)$.

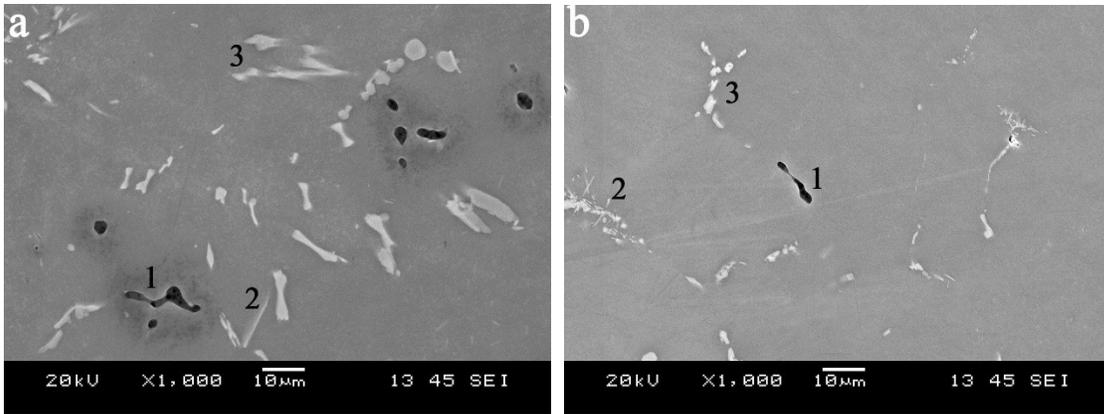
Fig. 5 shows SEM micrographs of the as-homogenized microstructure in the subsurface and bulk region. After homogenization, the β - Al_8Mg_5 intermetallics were entirely dissolved in both the subsurface and bulk region, which was in good agreement with the results reported in the literature [21]. As the β - Al_8Mg_5 eutectic phase solidified at a temperature close to 451°C , the present homogenization practice was adequate to completely dissolve these intermetallic particles. On the other hand, Mg_2Si particles were partially dissolved (close to 50%). It was reported [27] that the Mg_2Si phase changes during homogenization with the following sequences: 1) decomposition into small fragments, 2) diffusion-controlled spheroidization and 3) coarsening. Microstructural results revealed that Mg_2Si particles in this study experienced only the first two steps (the decomposition and spheroidization) without any noticeable coarsening. A limited dissolution of Mg_2Si for the alloys containing 2 wt.% Mg or higher has also been reported by Radetic et al. [28]. The Fe-rich intermetallic particles experienced only partial spheroidization, but their dissolution was negligible. It was observed that the metastable $\text{Al}_m(\text{Mn,Fe})$ had transformed into $\text{Al}_3(\text{Fe,Mn})$ during homogenization. This solid-state eutectoid phase transformation was discussed in detail by Li and Arnberg [23]. Therefore, there were two types of Fe-rich intermetallics that remained in the as-homogenized microstructure: plate-like $\text{Al}_6(\text{Mn,Fe})$ and needle-like $\text{Al}_3(\text{Mn,Fe})$ (Fig. 5). The quantitative results of the volume fraction of all intermetallics in the subsurface and bulk regions after homogenization are shown in Table 3. Although the total amount of Mg_2Si was considerably reduced during homogenization, the volume fraction of Mg_2Si was still five times higher in the inverse segregation zone than in the bulk. The amount of Fe-rich intermetallics in these samples was slightly decreased compared to the quantity in the as-cast samples, but the measured volume fraction was still two times higher in the inverse segregation zone relative to the bulk region.

Due to the large difference in the quantity of intermetallics (Mg_2Si and Fe-rich intermetallics) between the subsurface and bulk regions, the inverse segregation zone and meniscus bands were still clearly visible after homogenization. Another characteristic observed in the subsurface area of Al-Mg 5182 alloy was severe oxidization during homogenization. As shown in Fig. 6, the porous oxidized areas penetrated the cast surface inward, extending up to a few hundred micrometers into the material. The SEM-EDX results confirmed that the porous oxidized areas contained mostly AlMgO particles. Together with porosities and inclusions that were often encountered in the subsurface area (Fig. 3b), these defects provided favorable sites for the initiation of edge cracks during hot rolling.

Fig. 5. SEM images of the as-homogenized microstructure at a) the inverse segregation zone and b) bulk: (1) Mg_2Si , (2) $Al_3(Mn,Fe)$ and (3) $Al_6(Mn,Fe)$.

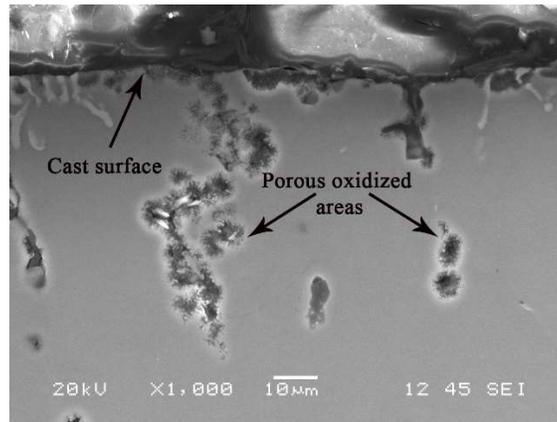
Fig. 6. Porous oxidized areas in the subsurface area of the ingot after homogenization.

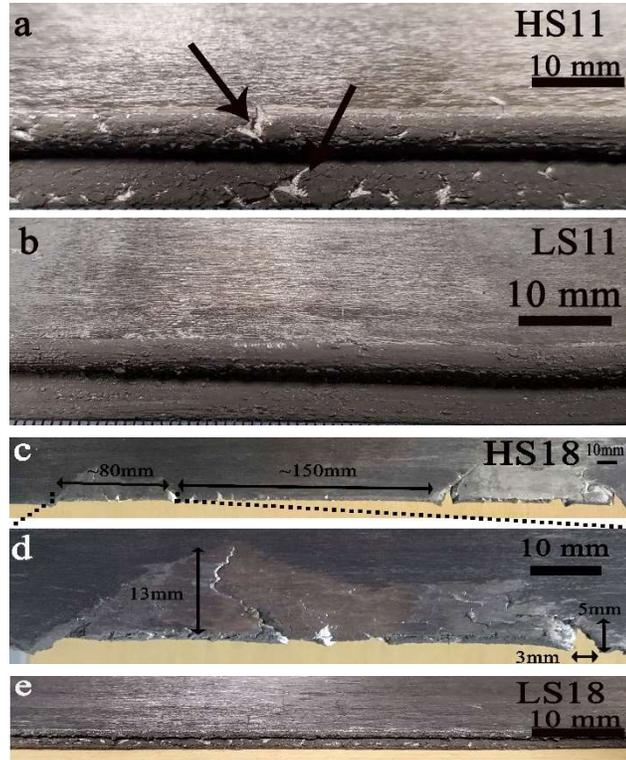
Cracks after pass #11 (Fig. 7a) were observed only in the sample with high Na content (HS11, Fig. 7a), and no visible cracks could be found in the sample with low Na content (LS11, Fig. 7b). By continuing the hot deformation (rolling to pass #18), the detrimental impact of Na on edge cracking susceptibility was more exposed. The macroscopic edge cracks encountered in the present work can be divided into two categories: 1) small cracks that remained superficially on the edge of the rolled strip with a maximum penetration depth of 3 mm, and 2) large cracks that were profoundly propagated into the bulk of the material. As the edges of the rolled strip are always trimmed out during the industrial rolling process, the small cracks are less harmful in terms of the rolling recovery, while the large cracks are particularly detrimental for the rolling process recovery and productivity. In the high Na sample (HS18), although the majority of the cracks were small cracks, a number of large cracks were observed on the edges and propagated up to 12-15 mm inwards (Fig. 7c and d). Furthermore, there were some triangular torn-off areas at the edges, where the cracks propagated up to 7 mm inward (Fig. 7c and d). These triangular cracks indicated the possibility of tearing off small pieces from the rolled block, which may fall out in the successive rolling passes. By moving away from the surface toward the bulk, the cracks tended to align toward the rolling direction. Another important feature of the large cracks was their repetitive pattern along the casting/rolling direction at intervals of 150 ± 20 mm, as shown in Fig. 7c. Unlike the sample HS18, in the low Na LS18 sample, no profound cracks were observed. As shown in Fig. 7e, the cracks in LS18 were all superficial with a depth of 1-3 mm, even after pass #18 with 96% reduction.

Fig. 7. The edges of high and low sodium rolled samples after passes #11 and #18 of hot rolling: a) HS11, b) LS11, c and d) HS18, e) LS18. The rolling direction is horizontal.

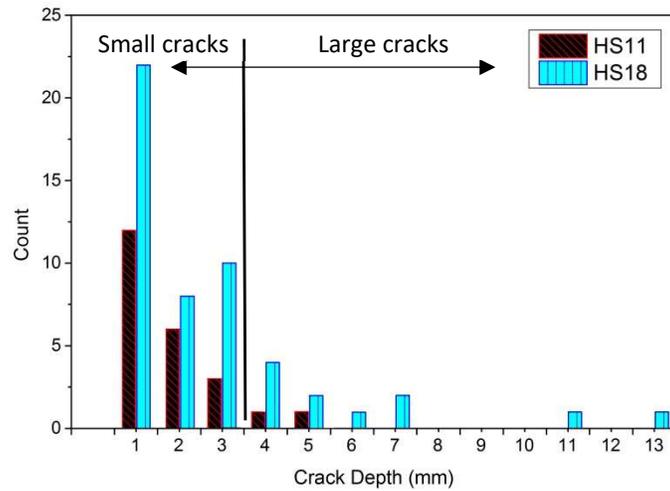
The quantity versus depth of cracks in high Na samples, measured over a 30 cm length in several samples in the rolling direction, is presented in Fig. 8. As the statistical results of Fig. 8 show, almost all cracks in the HS11 sample were small, with a maximum propagation depth of 3 mm. In the HS18 sample, a majority of the cracks (more than 80% in term of the crack number) were still small and superficial, but the rest were large and profound, with a depth of greater than 3 mm. In industrial practice, these large cracks could not only scrap the entire rolling product, but also jeopardize the rolling production line.

Fig. 8. Statistical data of the number and depth of edge cracks in HS11 and HS18 samples, measured over 30 cm length of rolled samples.

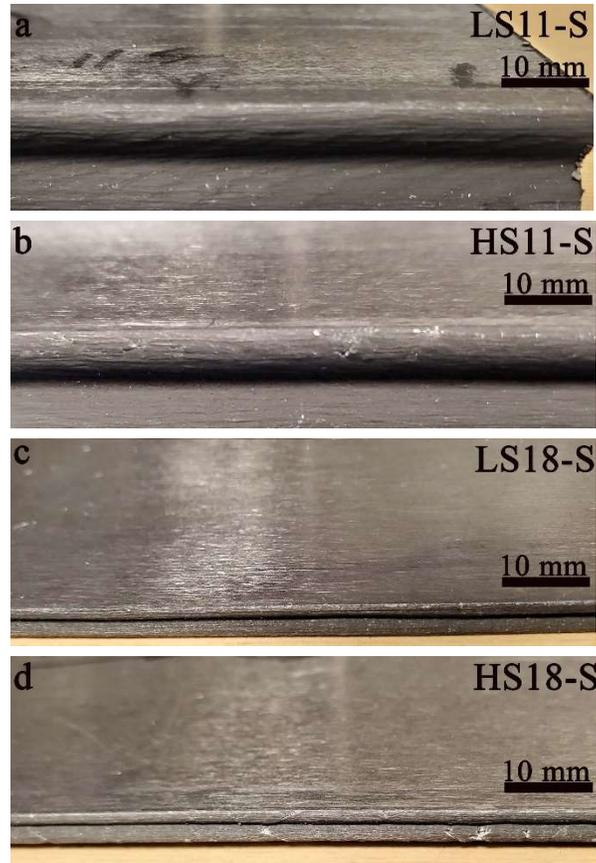
On the other hand, the edge cracks were mostly eliminated in the surface-scalped samples, where the side was scalped off 25 mm from the short side of the ingot. As illustrated in Fig. 9, almost no edge cracks could be found after pass #11 in both the low Na and high Na samples (Fig. 9a of LS11S and Fig. 9b of LS18S). After pass #18, no edge cracks were detectable in the low Na sample (LS18S, Fig. 9c), while a few small and superficial cracks with a depth of 1-2 mm were seen in the high Na sample (HS18S, Fig. 9d). It is important to highlight that the number of cracks in HS18S (Fig. 9d) was significantly lower even than that in the unscalped LS18 (Fig. 7e) and HS11 samples (Fig. 7a).

Fig. 9. The edges of the surface-scalded samples in both high and low sodium alloys after passes #11 and #18 of hot rolling: a) LS11S, b) HS11S, c) LS18 and d) HS18S.

ingot to remove all the inverse segregation zone and meniscus bands, the large and profound cracks completely disappeared, and the small and surficial cracks were reduced significantly (Fig. 9).

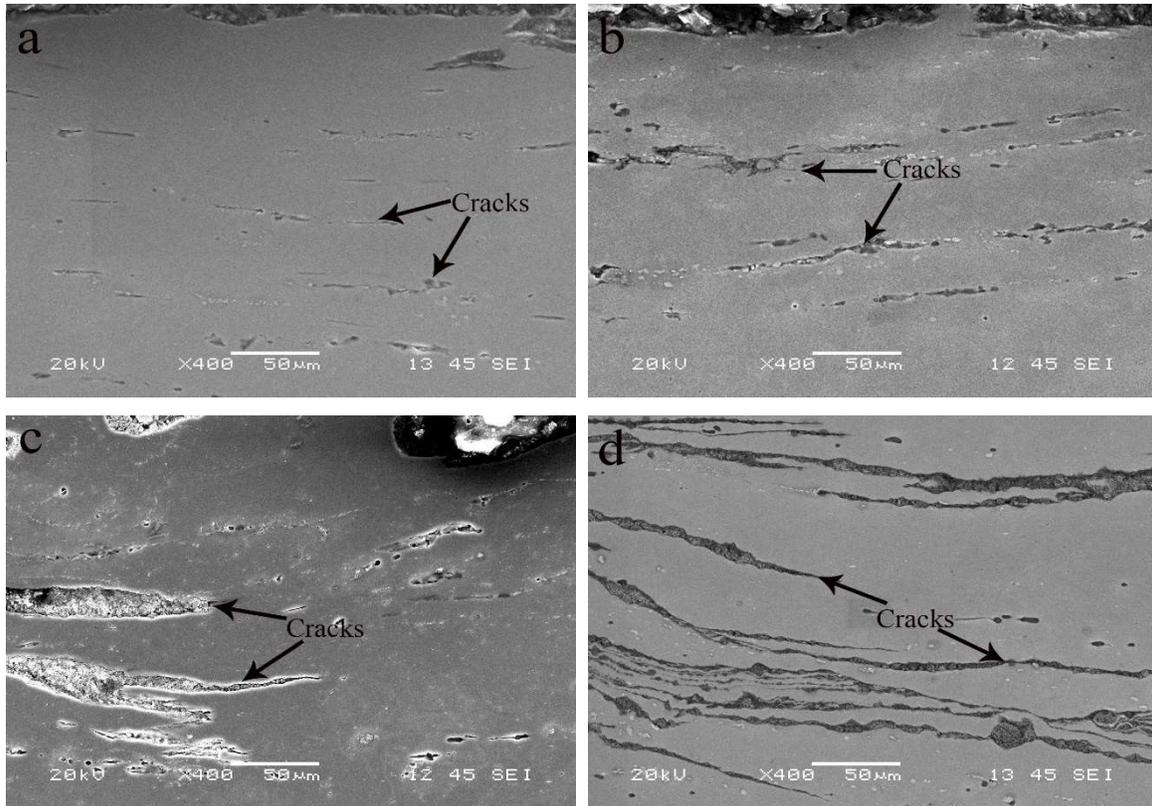
The cracking behavior in the subsurface area was further investigated by SEM, and the results for different samples are compared in Fig. 10. The macrocracks on the edges were generally composed of numerous microcracks, and their length and width varied significantly. Although the edge cracks in the LS11 sample were not visible on the macroscale (Fig. 7b), some microcracks were still detectable, with lengths and widths of less than 50 μm and 5 μm , respectively (Fig. 10a). By applying further deformation (after pass #18), the microcracks in the LS18 sample were enlarged and had a maximum length of 100 μm and a width of up to 15 μm (Fig. 10b). These cracks were mostly limited to within 1-2 mm of the sample edge area. In the high Na HS11 sample (Fig. 10c), the cracks were remarkably larger and several times wider than those in the LS11 sample. The high Na HS18 sample showed the most severe cracking (Fig. 10d). The cracks were mostly connected to the sample surface, elongated longitudinally up to several millimeters, and branched into numerous smaller cracks along the primary crack path. The cracks/cavities were mostly inclined toward the rolling direction as they traveled from the surface toward the bulk.

Fig. 10. SEM images of the microcracks of the rolled samples: a) LS11, b) LS18, c) HS11 and d) HS18. The top of each image is the edge of the rolled strip.

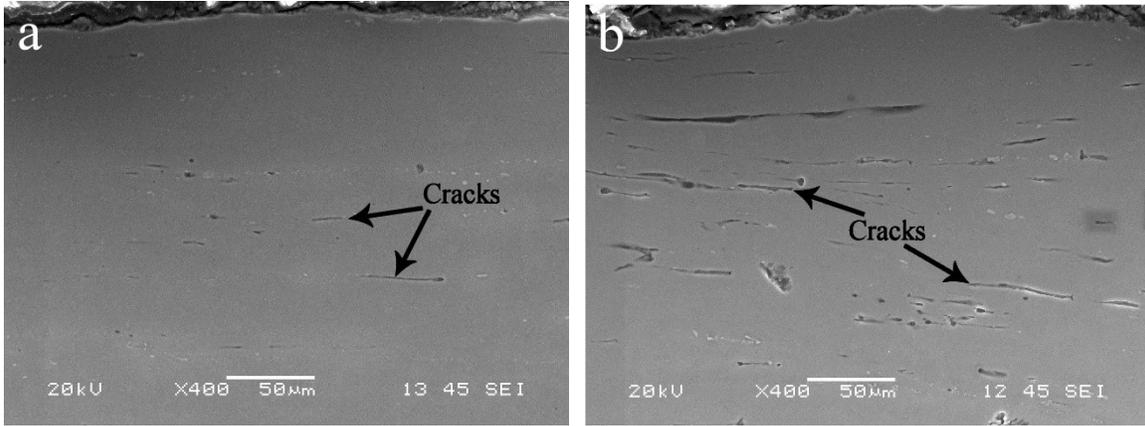
Microcracks could also be found in the surface-scalded samples after passes #11 and #18 (Fig. 11). In the low Na sample (LS18S), a few microcracks were detectable in edge

area of the sample. These small microcracks did not propagate and further develop into macroedge cracks, and they were also all restricted inside the ingot subsurface region without the connection to the ingot surface (Fig. 9b). In the high Na sample (HS18S), the number of microcracks increased considerably relative to the low Na sample (LS18S). Some of them were propagated and transformed to macroscopically visible edge cracks and were also connected to the sample surface (Fig. 9d). Nevertheless, it was evident that the number, length, and width of the micro- and macrocracks in the scalped samples (Figs. 9 and 11) were very restricted and were much smaller when compared to the unscalped HS11 and HS18 samples (Figs. 7, 8, and 10).

Fig. 11. SEM images of the microcracks in the surface-scaled samples: a) LS18S and b) HS18S. The top of each image is the edge of the rolled strip.

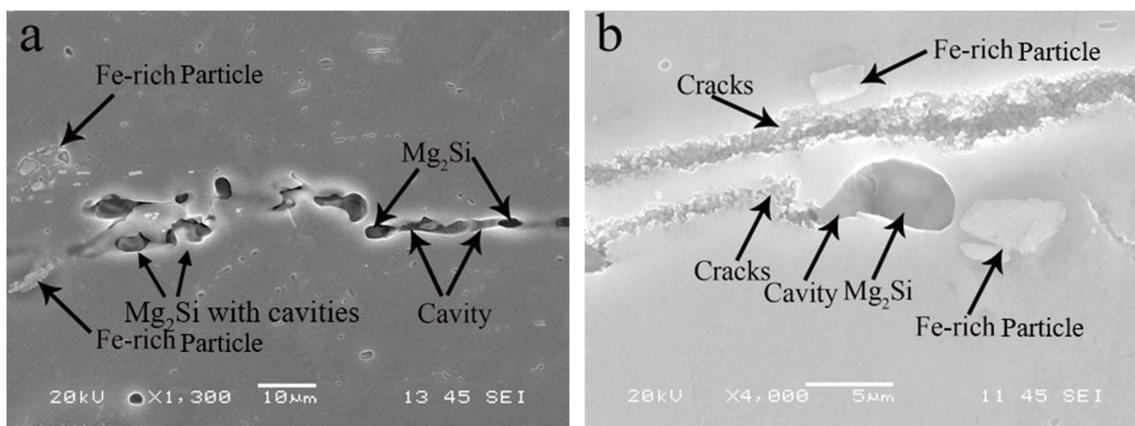
Fig. 12. SEM images of the Mg_2Si cavitation in the high Na samples: a) HS11 and b) HS18.

Results of numerous particle analyses showed that the cavities were formed in the detached area of Mg_2Si particles and extended into the matrix along the rolling direction. The phenomenon of the Mg_2Si particle-matrix decohesion and the subsequent cavitation is well depicted in Fig. 13. Figure 13a illustrates an early stage of particle debonding, with an approximately $1 \mu m$ cavity formed on one side of the Mg_2Si particle. Figure 13b presents the coalescence of several instances of Mg_2Si particle-matrix decohesion and subsequent growth to elongated cavities, leading to a path for crack propagation in the rolling direction. The particle decohesion and cavitation in the samples with high Na content (HS11 and HS18) were much more severe than in the low Na containing samples (LS11 and LS18). It is interesting to note that in both micrographs shown in Fig. 13, the Fe-rich intermetallic particles were well-bonded with the Al matrix.

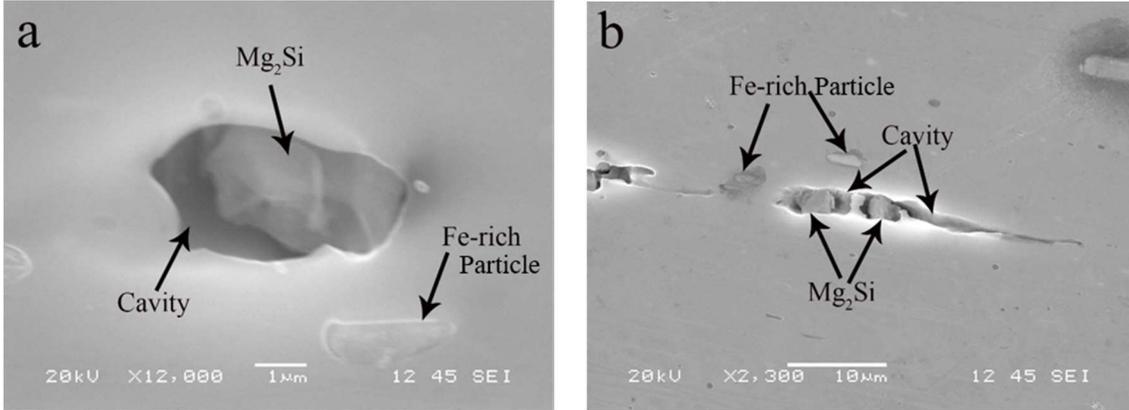
Fig. 13. Typical Mg_2Si particle-matrix decohesion and subsequent cavitation: a) an early stage of particle decohesion and b) the coalescence of cavities to form the microcrack. It is noted that the nearby Fe-rich particles were well-bonded with the matrix.

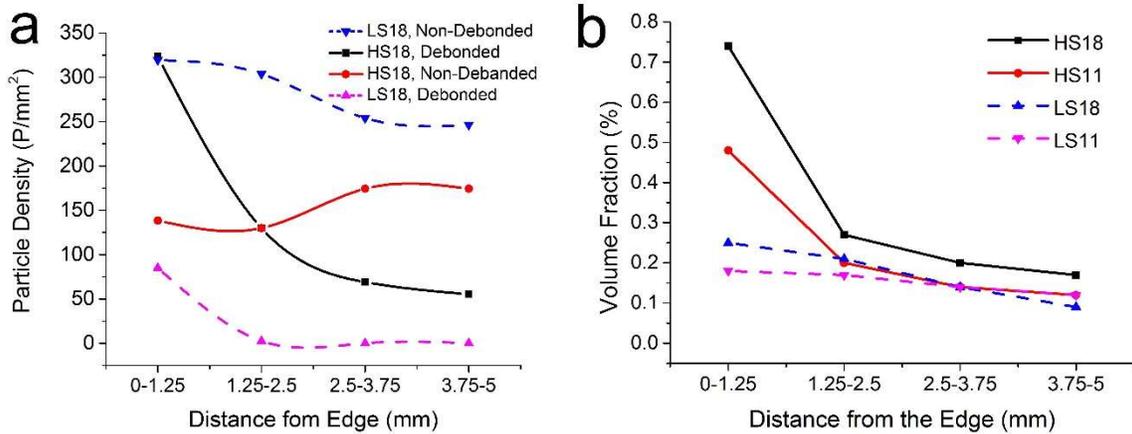
During SEM observation, it appeared that not all, but a considerable number, of Mg_2Si particles detached from the Al matrix and formed cavities. To better quantify the decohesion of Mg_2Si particles and their cavitation in the samples, the distribution of the non-debonded Mg_2Si and the debonded Mg_2Si with their adjacent cavities, as well as the area fraction of Mg_2Si plus the adjacent cavities, were measured. To do so, an area of approximately $50 mm$ in length and a $5 mm$ wide was carefully scanned in $1.25 mm$ intervals from the surface inwards by SEM for each sample. The results are presented in each $1.25 mm$ interval from the surface toward the bulk material, as shown in Fig. 14. In general, the number of debonded Mg_2Si particles in the first $1.25 mm$ interval was the highest, and it decreased from the surface inward (Fig. 14a). Both the number density of the debonded Mg_2Si particles and the ratio of the debonded to non-debonded particles in the first $1.25 mm$ interval for the HS18 sample containing high Na are very high at 325 particles per mm^2 and a ratio of 2.3 , respectively. In contrast, the number density of the debonded Mg_2Si particles and the ratio of the debonded and non-debonded particles for the LS18 sample containing low Na are quite low (80 particles per mm^2 with a ratio of 0.25). Furthermore, for the inside of the strip, the number densities of the debonded Mg_2Si particles of the HS18 sample are always considerably higher than those of the LS18 sample. As shown in Fig. 14b, the area fraction of debonded Mg_2Si and their associated cavities in the first $1.25 mm$ interval for the samples containing high Na was about three times higher

than the samples with low Na content (0.75% of HS18 vs 0.25% of LS18, and 0.5% of HS11 vs 0.18% LS11). The area fraction of the Mg_2Si cavitation became progressively smaller toward the sample inside, but the area fractions of the high Na sample (HS18 and HS11) were always higher than those of the low Na samples (LS18 and LS11).

Fig. 14. Comparison of Mg_2Si particles and their cavities in the sample edge area for both rolled plates containing high and low Na, a) the distribution of the non-debonded Mg_2Si and the debonded Mg_2Si with cavity and b) the area fraction Mg_2Si particles and their cavities.

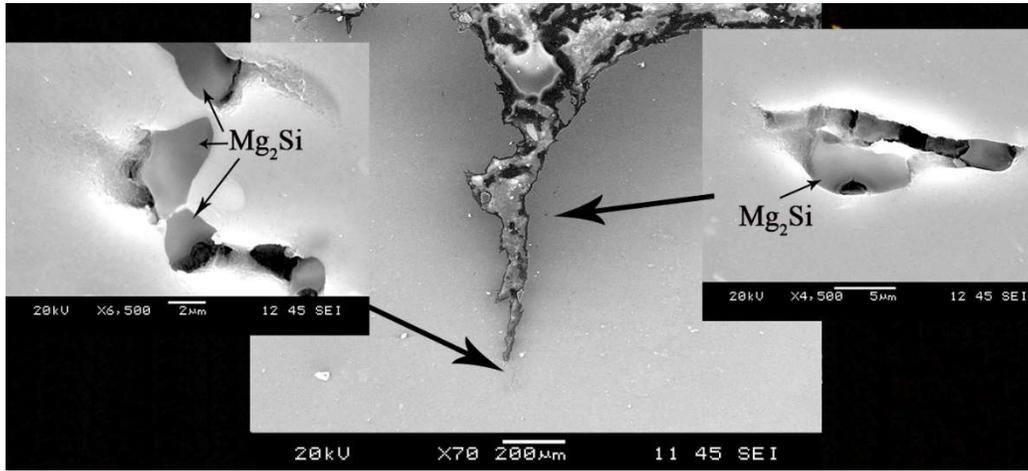
Fig. 16. Observation of Mg₂Si cavitation on an HS18 sample where the Mg₂Si particles and their associated, coalesced cavities were detected both along the crack path and in the crack tip.

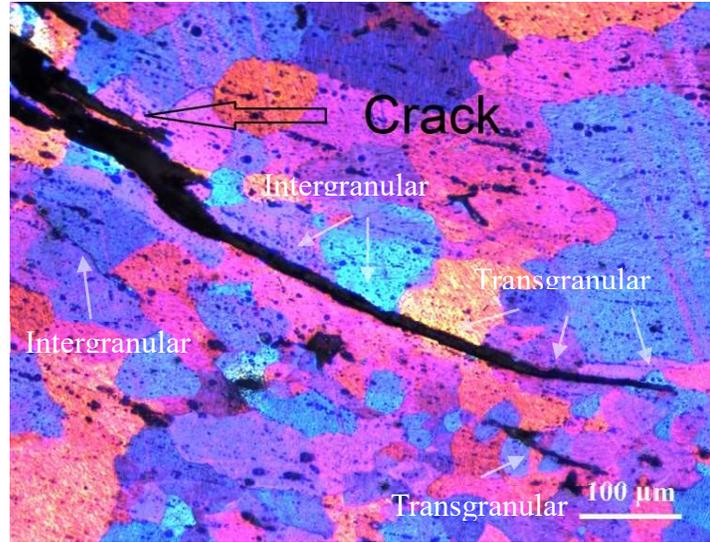
Several researchers reported that the Na-induced cracks were intergranular, owing to the segregation of Na on the aluminum grain boundaries [12,15,16]. In our observation, many edge cracks were found to be a mixture of intergranular and transgranular in nature. The large crack shown in Fig. 17 was intergranular in the middle and transgranular near the end of the path. The small crack at the right bottom of Fig. 17 was transgranular, and the thin crack on the left side was mainly intergranular. As mentioned above, Mg₂Si particles precipitated in the interdendrite regions during solidification, which might be in the interiors of the aluminum grain or in the aluminum grain boundaries. Therefore, the Mg₂Si cavitation, as discussed above, may provide a reasonable explanation for the intergranular and transgranular propagation of the edge cracking. On the other hand, considering that a portion of the Mg₂Si particles that originated from solidification were dissolved during homogenization, the low-melting-point Na-rich layer on the periphery of Mg₂Si particles could have dissolved back to the matrix and segregated along the aluminum grain boundaries, leading to the intergranular propagation of the crack.

Fig. 17. The edge cracks display the mixing of intergranular and transgranular propagation in HS18 sample. The grain structure was revealed under polarized optical microscopy using electrochemically etching in Barker solution.
