MÉMOIRE

L'UNIVERSITÉ DU QUÉBEC À CHICOUTIMI

***CORROSION BEHAVIOUR STUDY OF THE FORGED
AA6082 ALUMINUM ALLOY FROM DIFFERENT FEEDSTOCK***

DÉCEMBRE 2010

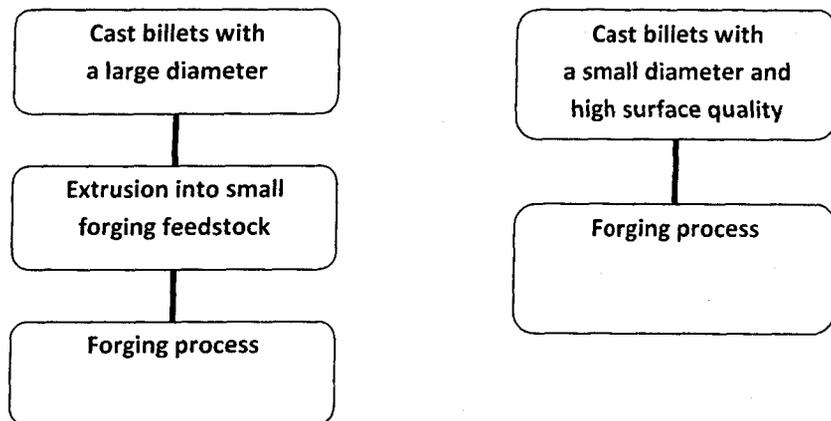
a) Traditional way to produce forging feedstock

b) New technological way to produce forging feedstock

This new method allows the manufacturing of small ready-to-forge cast billets without any intermediate processes (**Figure 1.2a vs 1.2b**). Transitional processes such as machining or extrusion were previously used to reduce the billet diameter and to ensure a smooth surface.

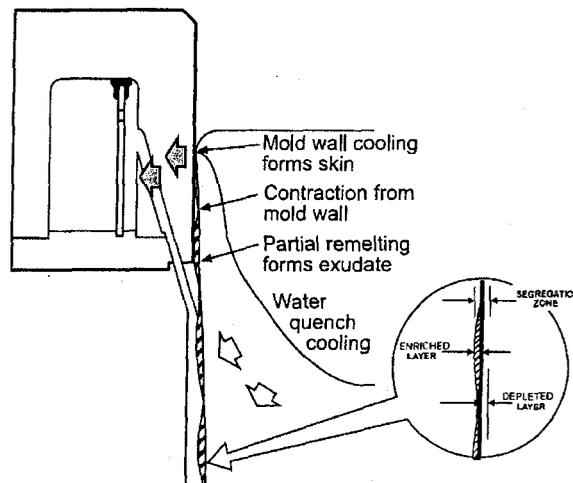
Figure 2.3: Segregation on a cast billet produced by the exudation phenomenon [3]

Solidification discontinuities produced by normal vertical casting technologies can affect extruded and forged processed parts. They are sub-divided into four main categories: 1) gas porosity (entrainment of air and hydrogen H_2), 2) shrinkage (macroporosity and microporosity), 3) hot tearing and cracks and 4) inclusions and segregations. The last discontinuities category which includes macro and microsegregations may have important detrimental effects on surface, mechanical and corrosion properties. In continuous and semi-continuous direct chill (DC) casting, solidification occurs predominantly when heat escapes the solidifying ingot after the ingot exits the mold bore, and comes into direct contact with a stream of water. To a lesser extent, heat is also removed through the mold wall. The heat removal causes a thin skin or shell to form around the molten sump. Therefore, the shell thickness and strength are affected by how much heat is removed during the primary cooling and the alloy that is being solidified. During the shell formation, a variation in the concentration of alloying elements occurs. The area where this difference in concentration happens is often referred to the «Shell zone». It is composed of an enriched layer as the inverse segregated region, and is followed by a depleted layer (*Figure 2.3*).

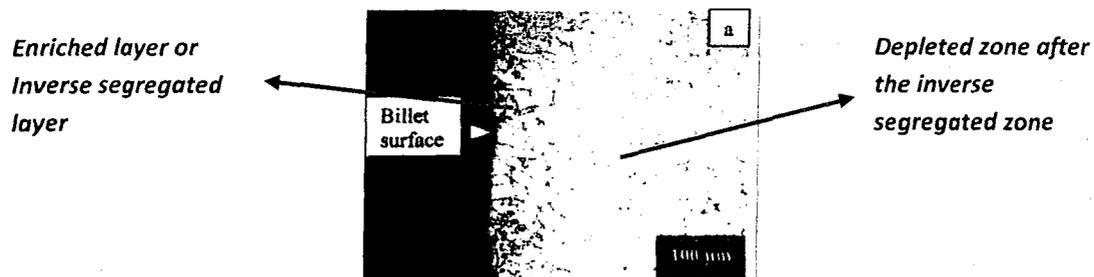
Figure 2.4: A typical view of microstructural features of the SSZ (Surface Segregation Zone) in an AA6082 aluminum alloy [4].

The result of these phenomena is a layer, largely depleted of solutes, being created just behind the enriched layer. Optimizing the water quench with a mold bore length and mold wall heat transfer can greatly reduce this segregation zone. As-cast microstructural studies of cross sectional slices of vertical direct chill cast billets of AA6082 and other aluminum alloys were investigated to identify and characterize these segregated layers [4,5,6,7]. *Figure 2.4* shows a typical segregation layer at the surface of AA6082 as-cast billets.

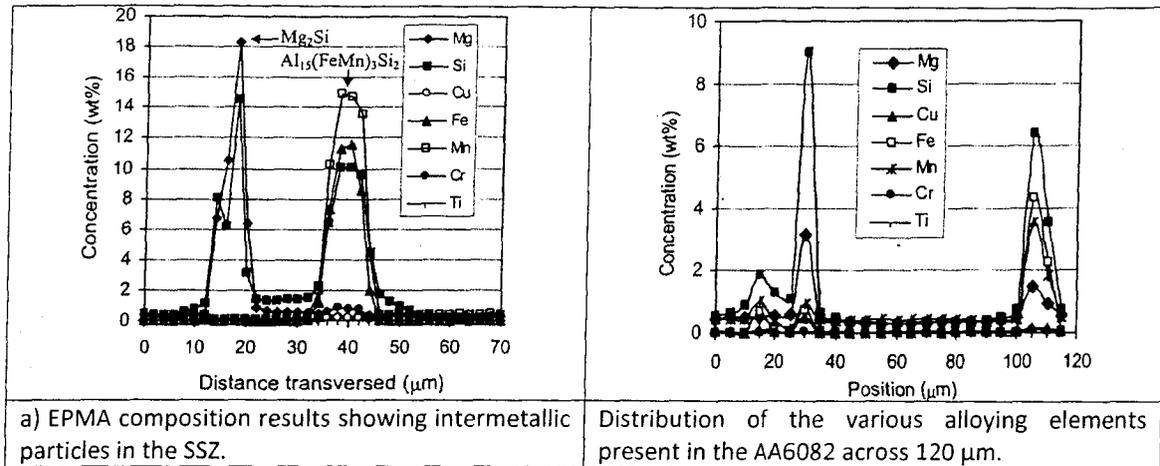
An EPMA approach (chemical analysis by an Electron Probe Microanalysis technique) was used to identify intermetallic phases in the segregated surface zone. The bright particles were identified to be $\text{Al}_{15}(\text{FeMn})_3\text{Si}_2$ and the dark particles Mg_2Si (*Figure 2.5a*). Linear composition analysis with EPMA technology allows the quantification of major elements in the first 120 μm of the as-cast billet surface (*Figure 2.5b*).

Figure 2.5: EPMA analysis to identify intermetallic phase particles in the SSZ [8]

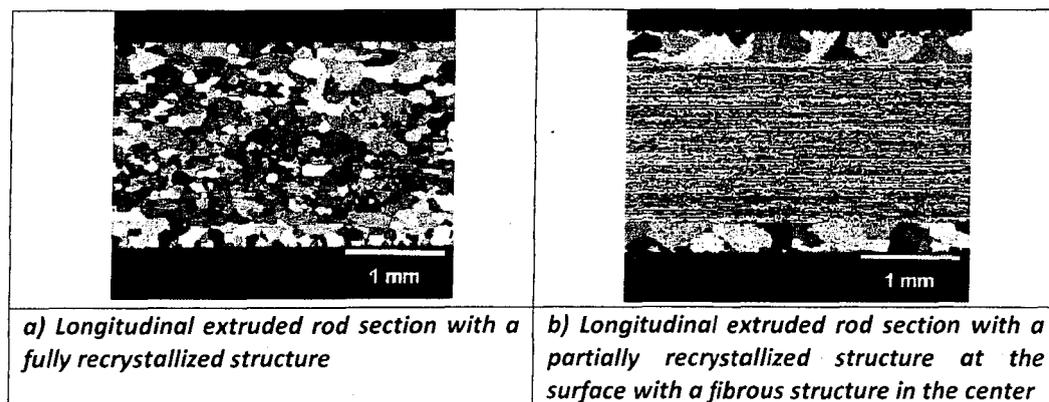
Figure 2.7: Typical macrostructures of hot extrusion with specific parameters [10]

3) The pressure applied on the aluminum billet will force the metal to enter and take the shape associated with the steel die. As the metallurgical history states, many parameters can influence the final extruded product the preheating temperature, the ram speed, the extrusion temperature and the cooling system. Normally, a good parameter adjustment allows the extruder to obtain two types of microstructures with this process. The first option is a fully recrystallized grain structure and the second possibility is a partially recrystallized grain at the surface with a fibrous structure in the center (*Figures 2.7a and 2.7b*).

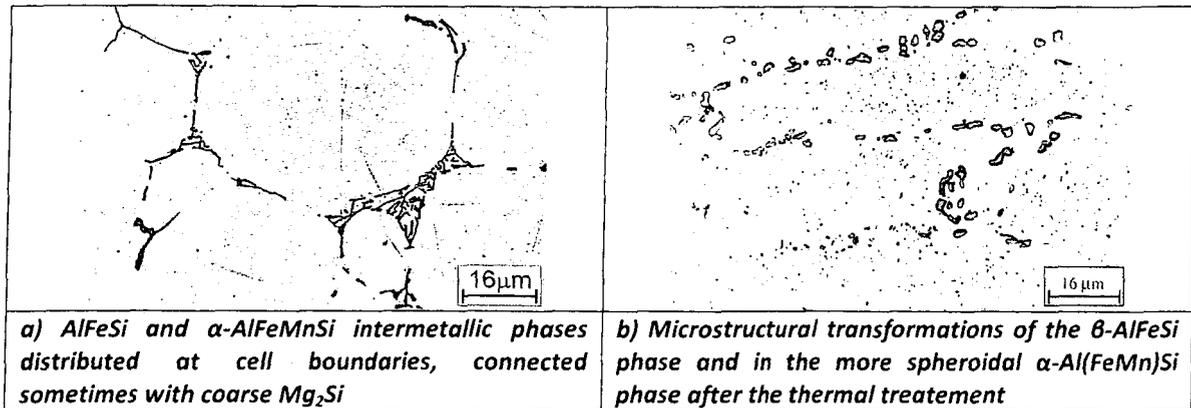
Figure 2.9: Microstructures of AA6082 alloy before and after the homogenization treatment at 570°C/6 h and air cooled [15]

Solutionizing and aging heat treatments after the final forging process may have important impacts on mechanical and microstructural properties by producing a maximum of round β -Mg₂Si precipitated hardening particles. Grazyna Mrowka-Nowotnik and Jan Sieniawski from the Rzeszow University of Technology in Poland studied the influence of the cooling conditions after homogenization and aging of the AA6082 aluminum alloys [15]. The alloys were heat treated [-T4] with a wide range of solution heat treatment temperatures from 510 to 580°C. During the homogenization treatment at 570°C and air cooled, microstructural transformations of the β -AlFeSi phase and in the more spheroidal α -Al(FeMn)Si phase occurred in the AA6082 alloys (**Figures 2.9a and 2.9b**).

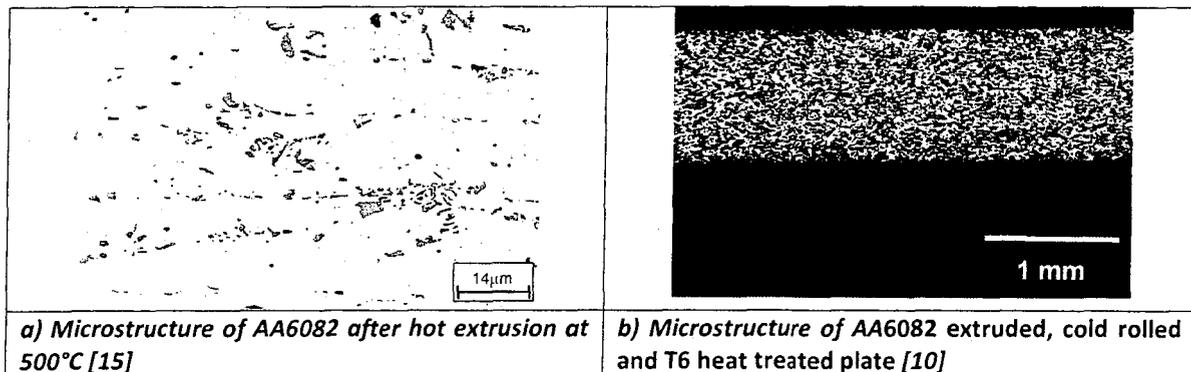
During the hot extrusion of ingots, particles of the intermetallic phase position themselves parallel to the direction of the plastic deformation and therefore allow formation of the band structure (**Figure 2.11**). After the deformation process, a T61 heat treatment temper is commonly used to produce a supersaturated solid solution of elements. This optional step involves the formation of finely dispersed precipitates and small grain structures with high mechanical properties (**Figure 2.10**).

Figure 2.10: Hot extrusion and T6 heat treatment microstructures for the AA6082 alloy

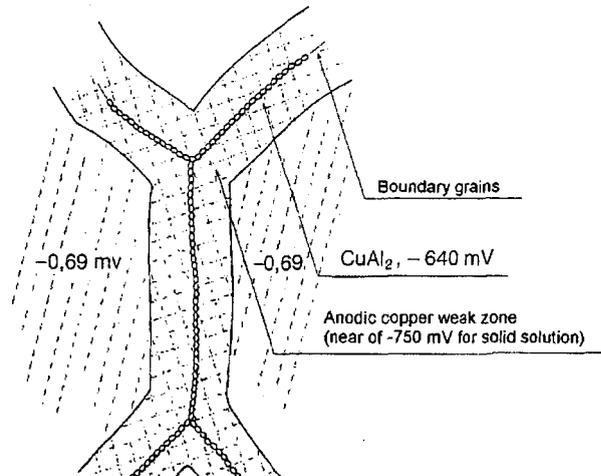
2) Intergranular corrosion (IGC) is the selective dissolution of the grain boundary zone, while the bulk grain is not attacked. IGC is also caused by microgalvanic cell action at the grain boundaries. The susceptibility to IGC is known to depend on the alloy composition and thermomechanical processing. Grain boundaries are sites for precipitation and segregation, which makes them physically and chemically different from the matrix. Precipitation of noble particles at the grain boundaries depletes the adjacent zone of these elements, and the depleted zone becomes electrochemically active. The opposite outcome is also possible; precipitation of active particles at the grain boundaries would make the adjacent zone noble. **Figure 2.14** shows the first case where noble particles induce corrosion at the grain boundaries for AlMgCu alloys. These noble intermetallic particles (Al_3Fe , Al_2Cu), coupled with the solid solution (aluminum matrix), will produce a severe microgalvanic coupling [16, 19, 26, 40].

Figure 2.14: Intergranular corrosion (IGC) with Cu particles in 2XXX series [16]

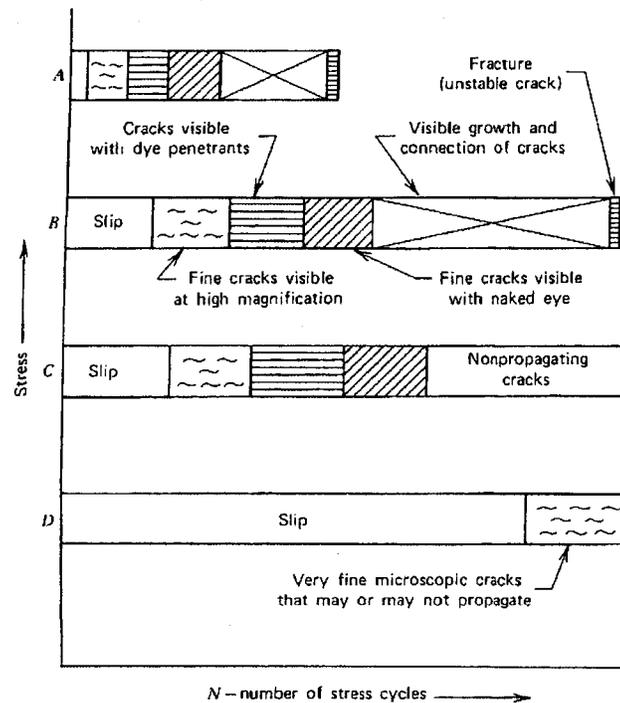
The typical stages of the fatigue damage process are described in **Figure 2.17** where the slip first occurs, followed by fine cracks that can be seen only at high magnification. These cracks continue to grow under cyclic loading and eventually become visible to the naked eye [21].

Figure 2.17: Schematic representation of the fatigue process for a S-N curve (Wöhler) [21]

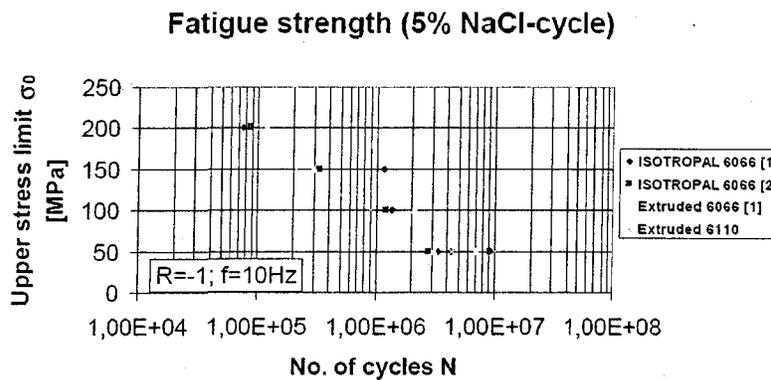
Another research paper [1] on fatigue strengths compares the as-cast ISOTROPAL alloy to the same extruded materials in a 5% sodium chloride media. The 6066 Al and the 6110 Al aluminum alloys in the 6xxx series were tested in corrosion-fatigue. Results show an important decrease in fatigue life assessment where stresses varied from 200 and 50 MPa (Figure 2.19).

Figure 2.19: Fatigue Wöhler curves for 6066 and 6110 aluminum alloys in a 5% NaCl corrosive solution [1]

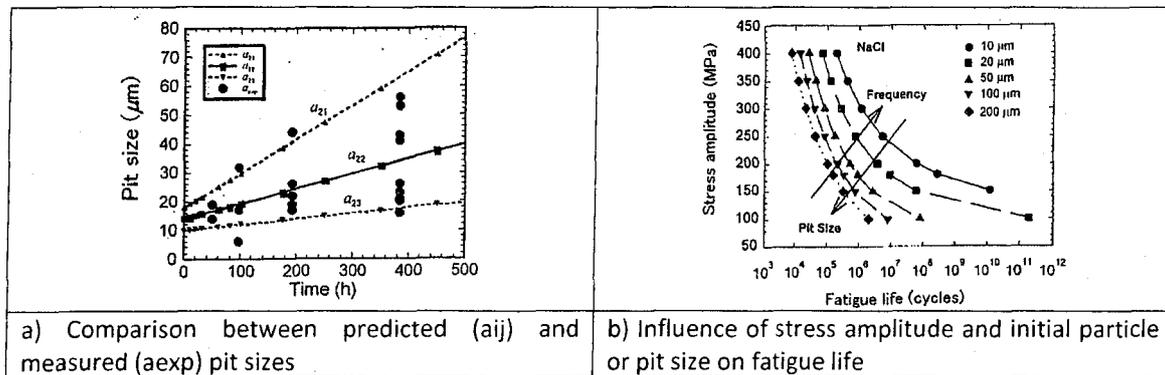
fatigue cracking and significantly reduce the serviceable life of a component. Corrosion-fatigue cracking would nucleate at severe corrosion pits. The predicted fatigue lives at different stress levels from 100 to 400 MPa for an initial pit radius of 10 to 200 microns were identified (**Figures 2.20a and 2.20b**).

Figure 2.20: Relationship between pit sizes with corrosion-fatigue life for a 2024-T3 aluminum alloy exposed to 0.5 M NaCl [22]

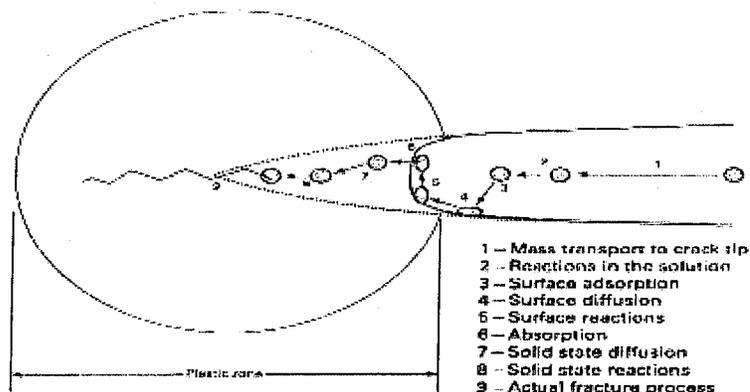
Corrosion-fatigue depends on many relations between the material, the environment, the electrochemical conditions and the mechanical loading parameters. The cracking phenomenon for ductile alloys involves plastic deformation where this localized deformation is induced by fatigue loadings that cause a final failure below the yield stress. Many corrosion-fatigue mechanisms exist to explain the enhanced crack growth rates with low degrees of success. The fatigue crack growth rate parameter is a significant factor in characterizing this phenomenon. The generalized corrosion-fatigue cracking mechanism involves an anodic dissolution at the crack tip (i.e. electrochemical propagation theory) with a hydrogen embrittlement supplement (*Figure 2.22*).

Figure 2.22: Crack tip to explain anodic dissolution of passive aluminum alloys [26]

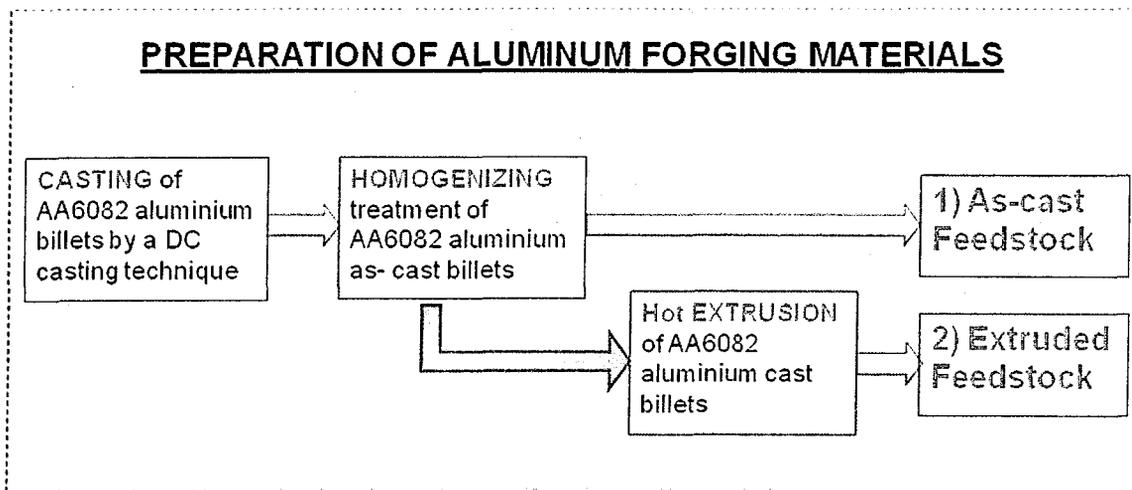
Figure 3.1 presents material preparation ways to be used for the corrosion tests.

Figure 3.1: Experimental flow of materials preparation as forging feedstock

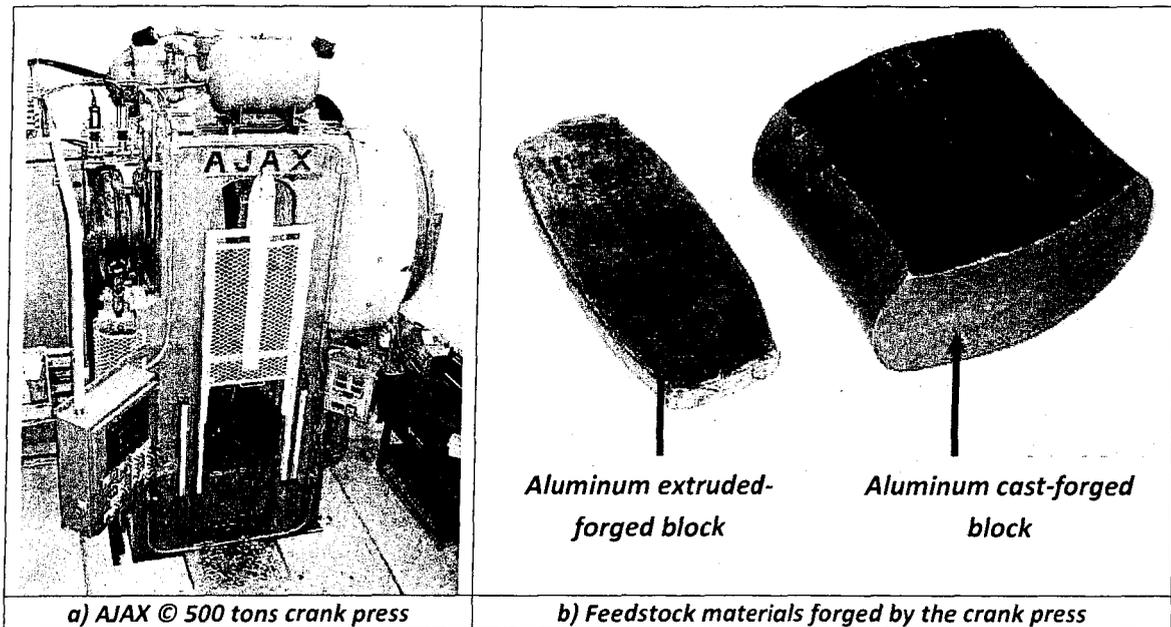
Figure 3.3: Mechanical forging press used to prepare corrosion coupons

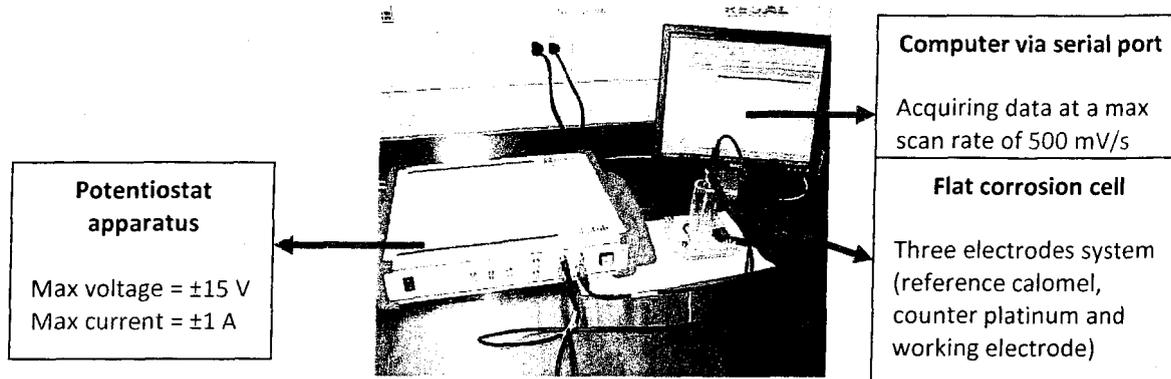
Figure 3.5: Electrochemical system made from Radiometer® that identify the corrosion susceptibility of forged materials by potential and current measurements

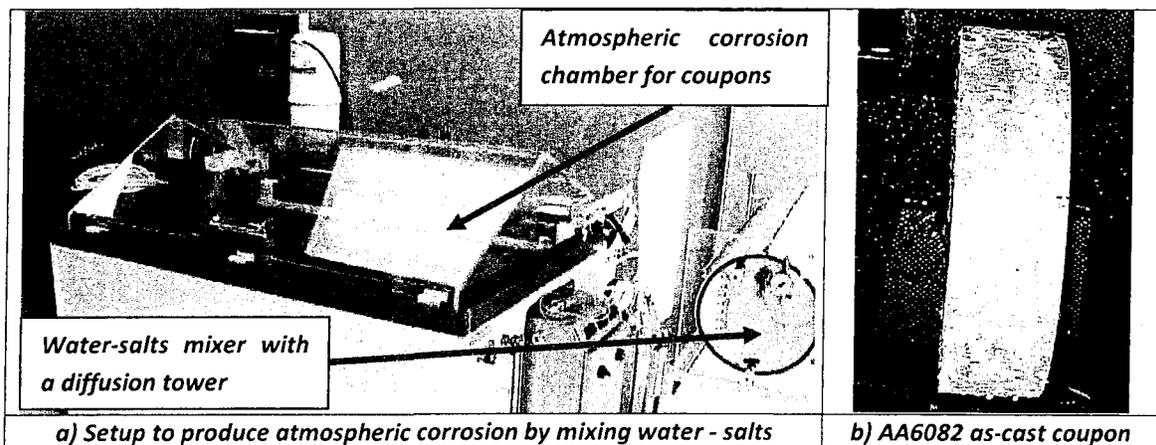
Figure 3.6: Singleton © salt fog spray apparatus and specimen example with corrosion products after 168 hours of exposure time

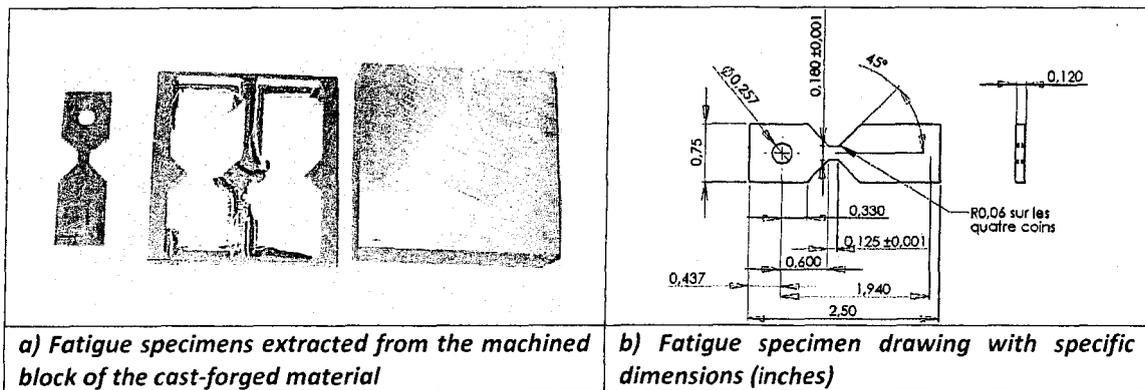
Figure 3.8: Fatigue specimen extraction from machining and its dimensional tolerances

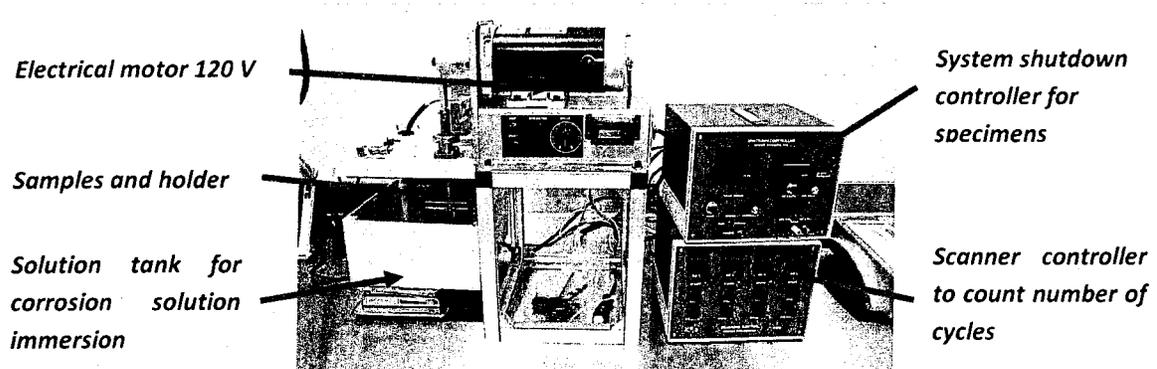
Figure 3.10: 4 samples flexural bending fatigue apparatus made by Fatigue Dynamic inc© with a corrosion immersion cell

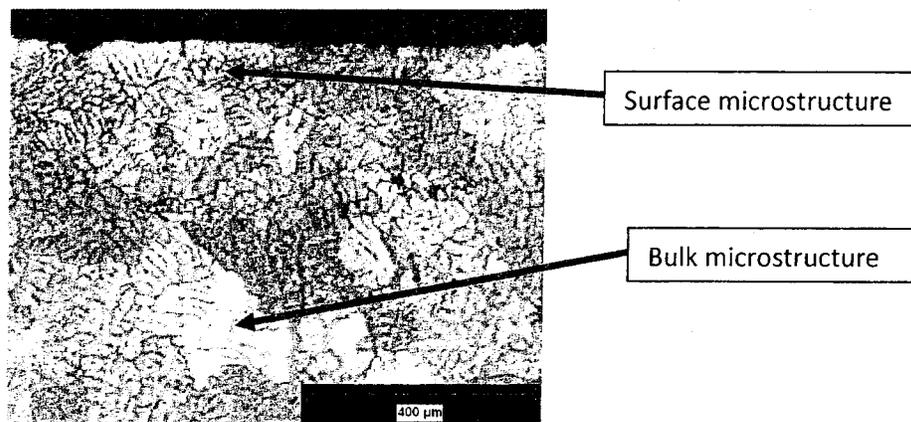
Figure 4.1: Optical macrograph of AA6082 as-cast aluminum material with a uniform grain structure (Modified Poulton etchant, 50X)

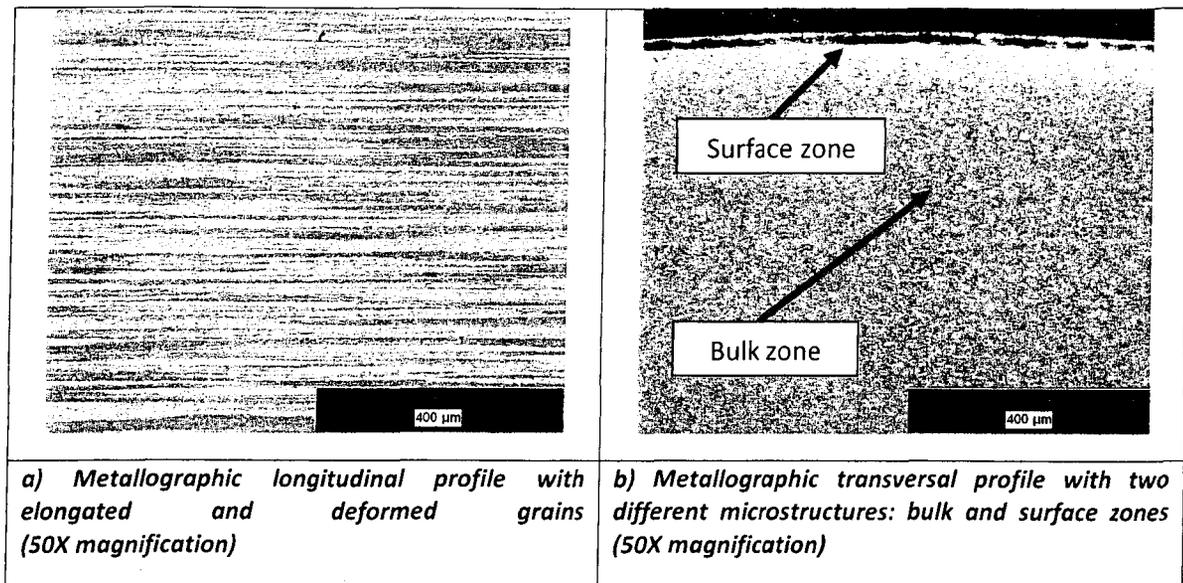
Figure 4.3: As-extruded AA6082 feedstock revealing an elongated structure with different microstructural zones (Modified Poulton etchant, 50X magnification.)

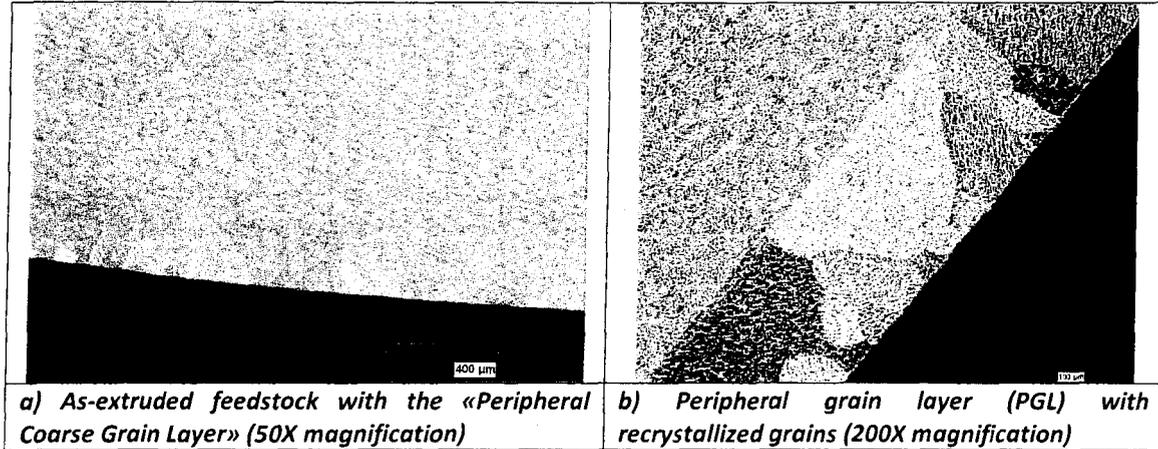
Figure 4.4: Transversal micrographs of AA6082 aluminum extruded material exhibiting the presence of a recrystallized grain structure at the surface (Modified Poulton etchant)

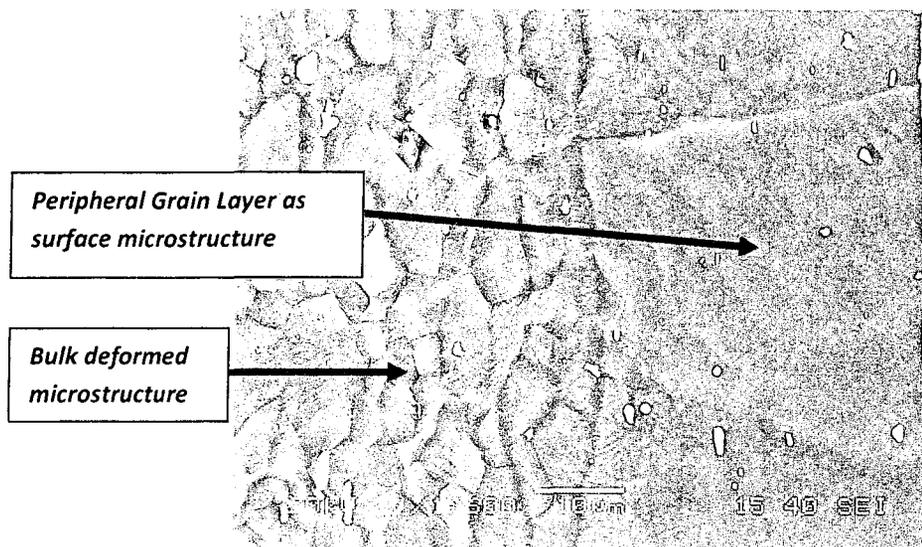
Figure 4.7 SEM micrograph of an as-extruded AA6082 aluminum alloy profile exhibiting the transition between the internal core microstructure and the Peripheral Grain Layer (PGL) (Modified Poulton etchant, 1600X magnification, 20 KeV, SEI source)

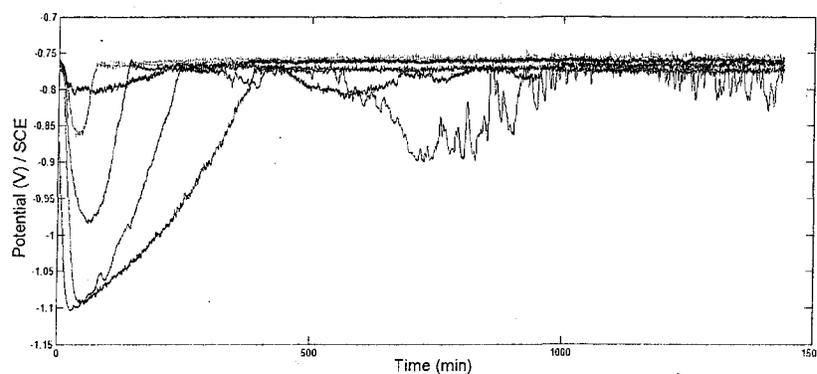
Figure 4.23: Five OCP curves of cast-forged samples in a deaerated 3.5 w/v% NaCl solution during 24 h.

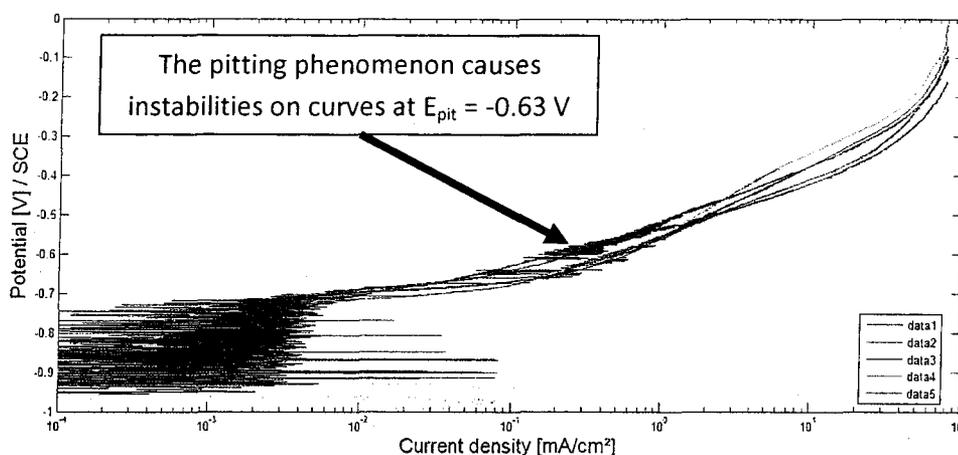
Figure 4.24: Anodic polarization curves of cast-forged samples in a deaerated 3.5 w/v% NaCl solution during 24 h. at a 2mV/s scan rate. Instabilities on these curves were produced by a corrosion pitting phenomenon.

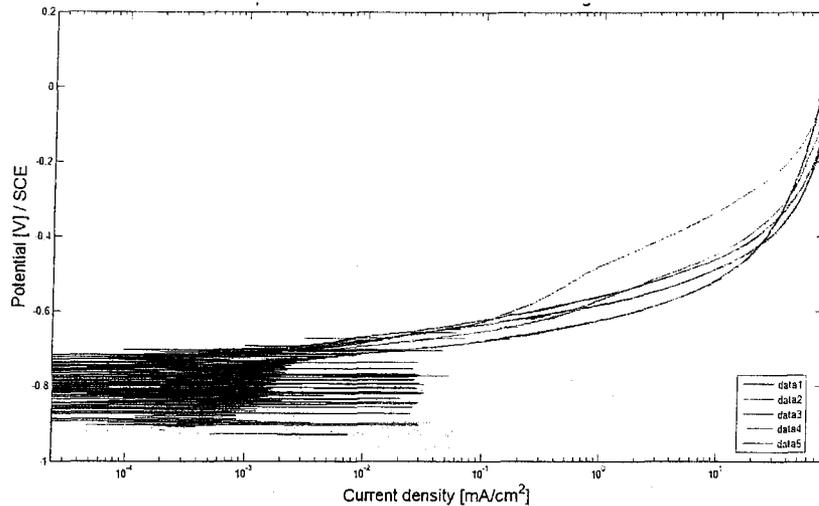
Figure 4.34: Anodic polarization curves of extruded-forged samples in a deaerated 3.5% NaCl solution during 24 h at a 2 mV/s scan rate

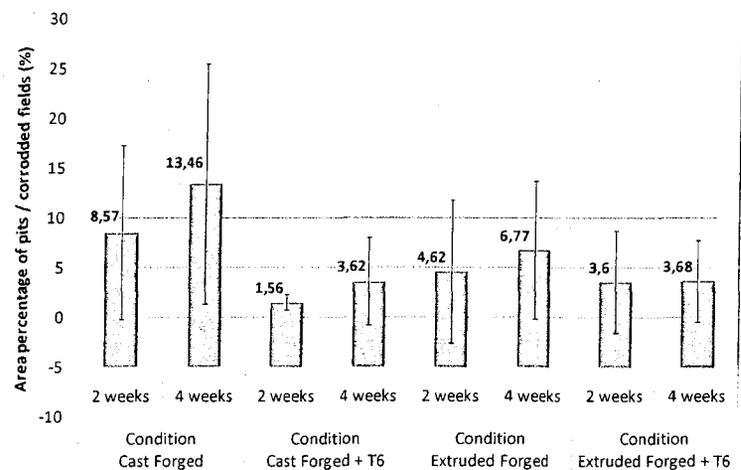
Figure 4.51: Relative area percentage of corrosion pits (%) per corroded field analyzed for different metallurgical conditions during salt fog spray testing

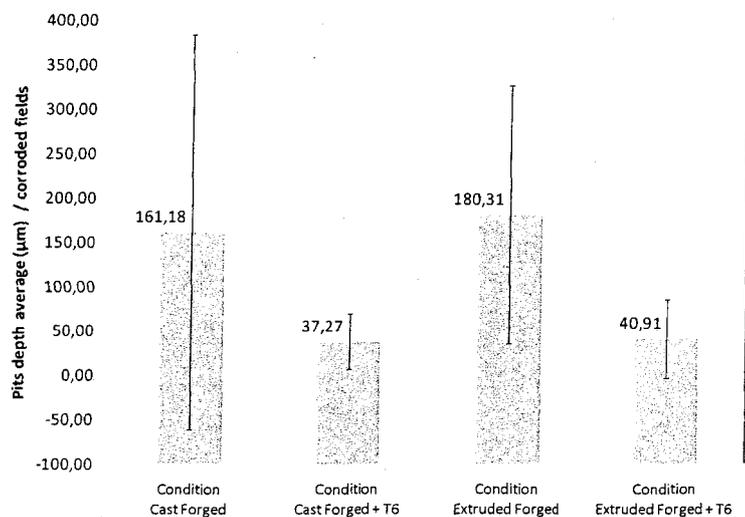
Figure 4.56: Individual pit depths for different metallurgical conditions after 4 weeks of salt spray testing

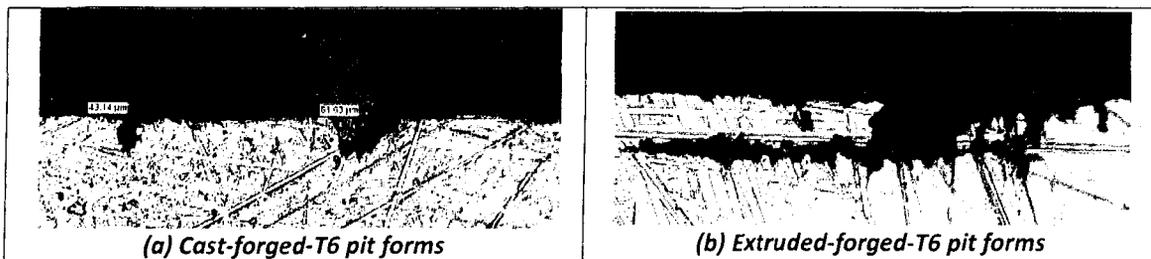
Figure 4.57: Typical profile of corroded sections with pit depths and forms after four weeks of duration periods (100 X magnification)

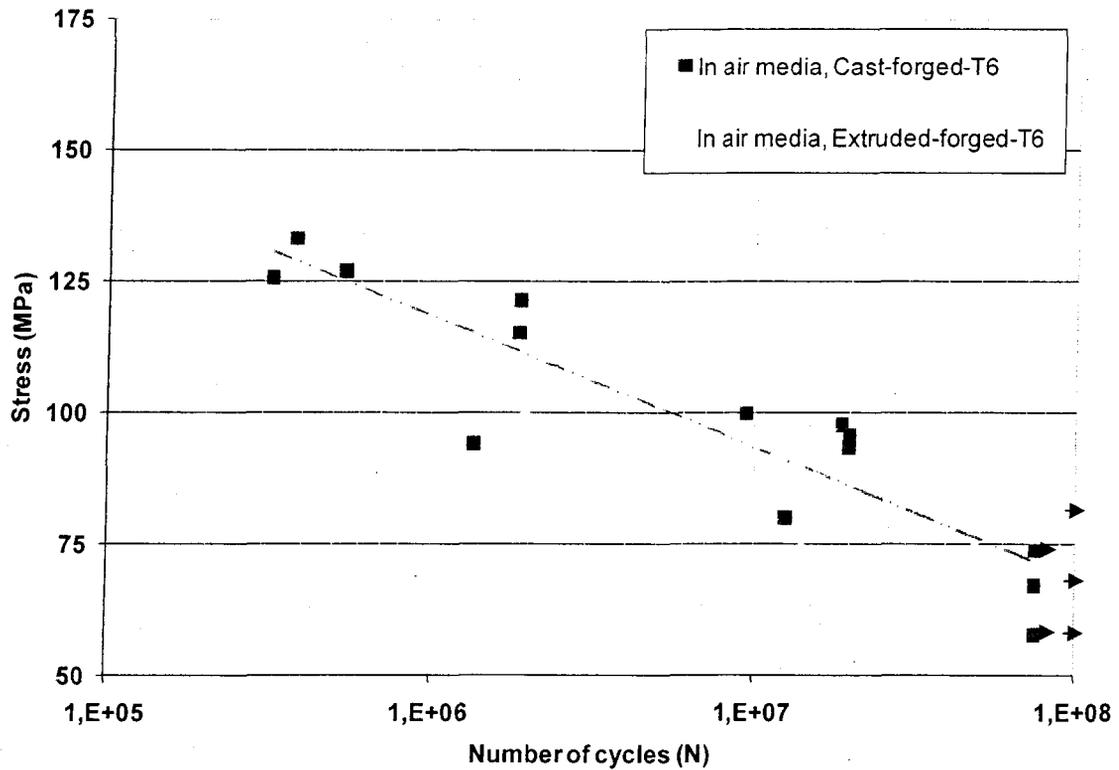
Figure 4.58: Reverse bending fatigue stress-life in air medium of both forged -T6 HT materials

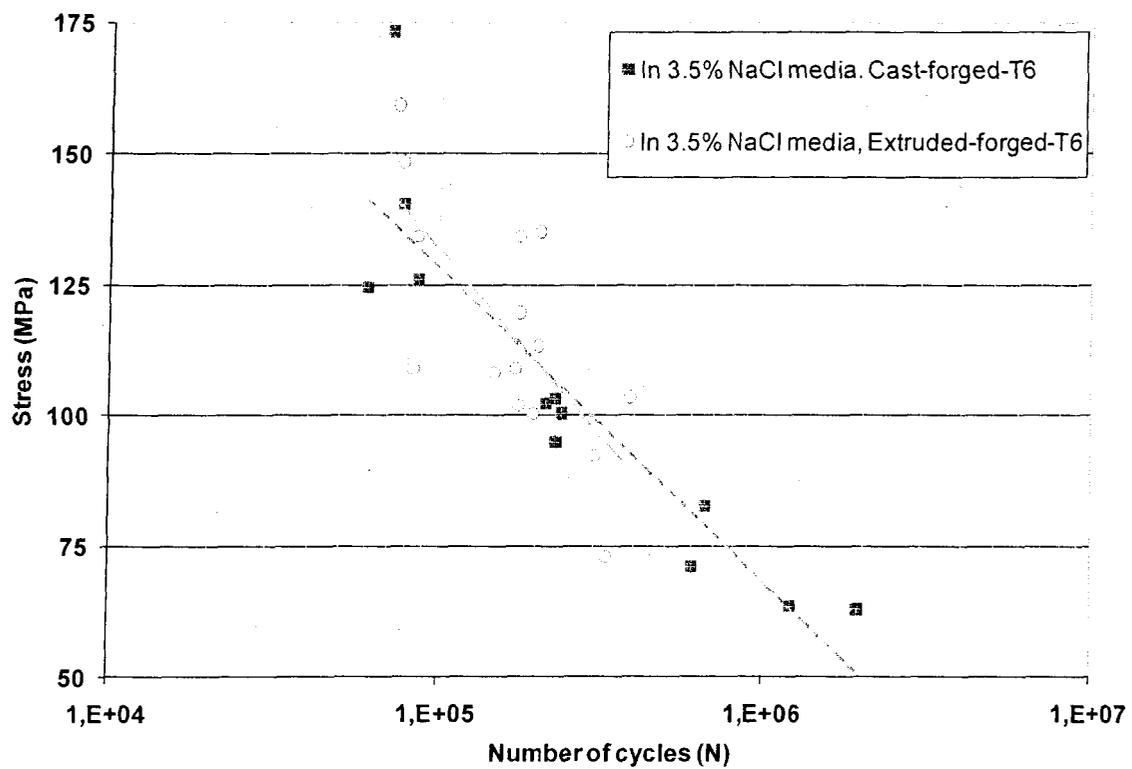
A general observation was established for these fatigue results with a corrosive effect. The number of cycles in an air environment was approximately 1×10^3 higher than in a 3.5 w/v% NaCl environment. Similar results were obtained for low and high stresses applied. At high stress levels, the performance of extruded-forged material seemed greater with an upper fatigue life limit. The best example to examine this fact was obtained at 135 MPa where fatigue specimens from extruded materials resisted a minimum of two life durations to the cast materials' one life duration. Otherwise, the cast-forged materials were found to be better when low stresses under 100 MPa were applied.

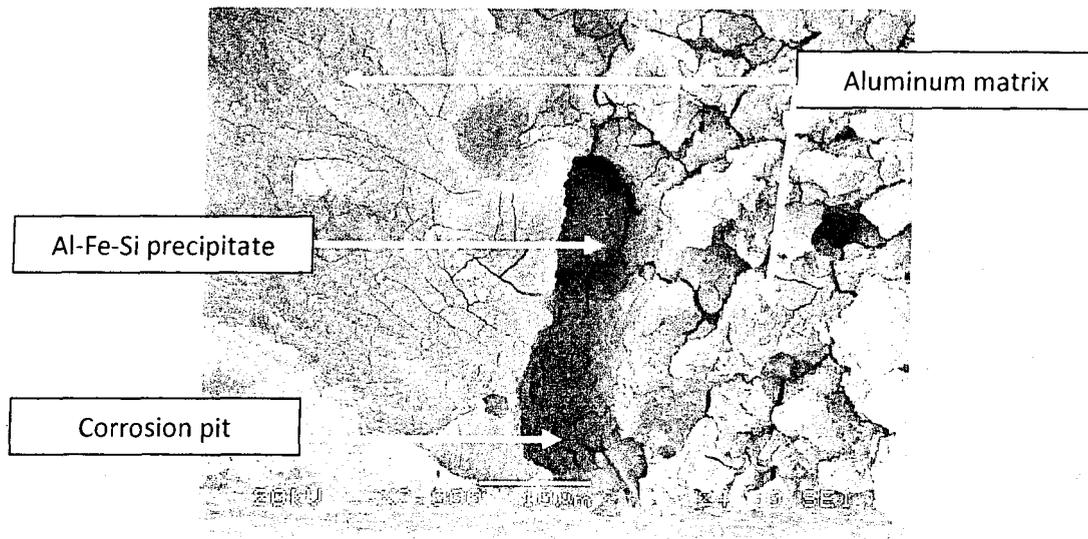
Figure 4.64: AA6082 cast-forged SEM microfractograph of an initiation site with a microgalvanic couple AlFeSi phase – Aluminum matrix (2000X magnification)
